4- UNITED STATES DEPARTMENT OF AGRICULTURE
SOIL CONSERVATION SERVICE RIO GRANDE DISTRICT
REGION EIGHT - RIO GRANDE SURVEY

REPORT ON
SURVEYS, EXAMINATIONS, AND INVESTIGATIONS
MADE NEAR SAN MARCIAL, NEW MEXICO
DURING 1936, 1937, and 1938

Subject: Siltation Conditions in and near
San Marcial, New Mexico, - 1936-38

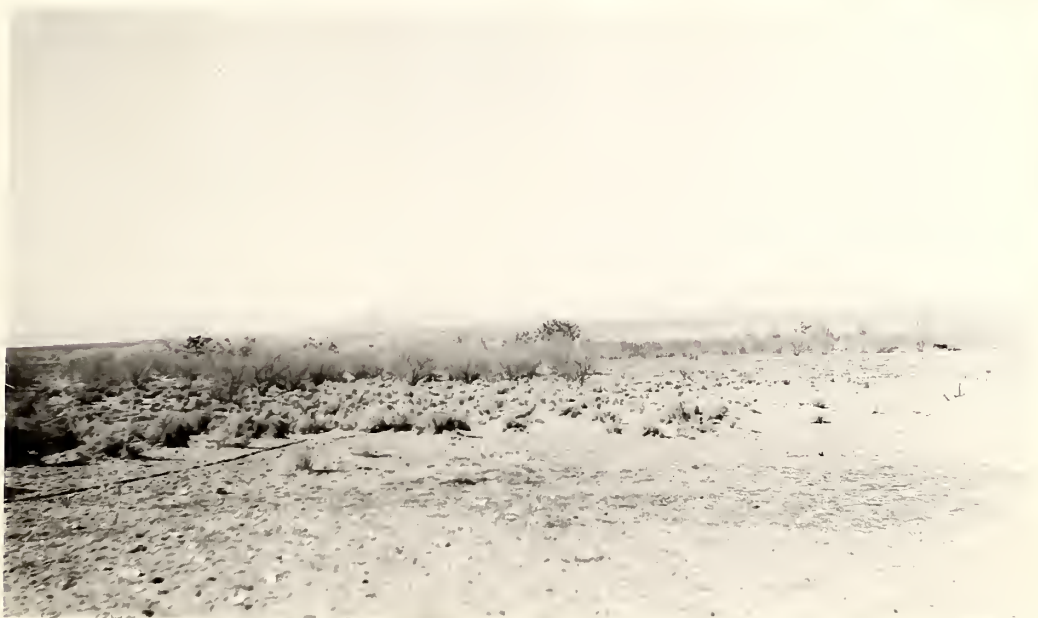
Rio Grande Valley. Cross section line. 415 feet westerly from triangulation station Arena and at Station 97+00. Looking northwesterly. Socorro Peak barely shows near the center. December 12, 1936.

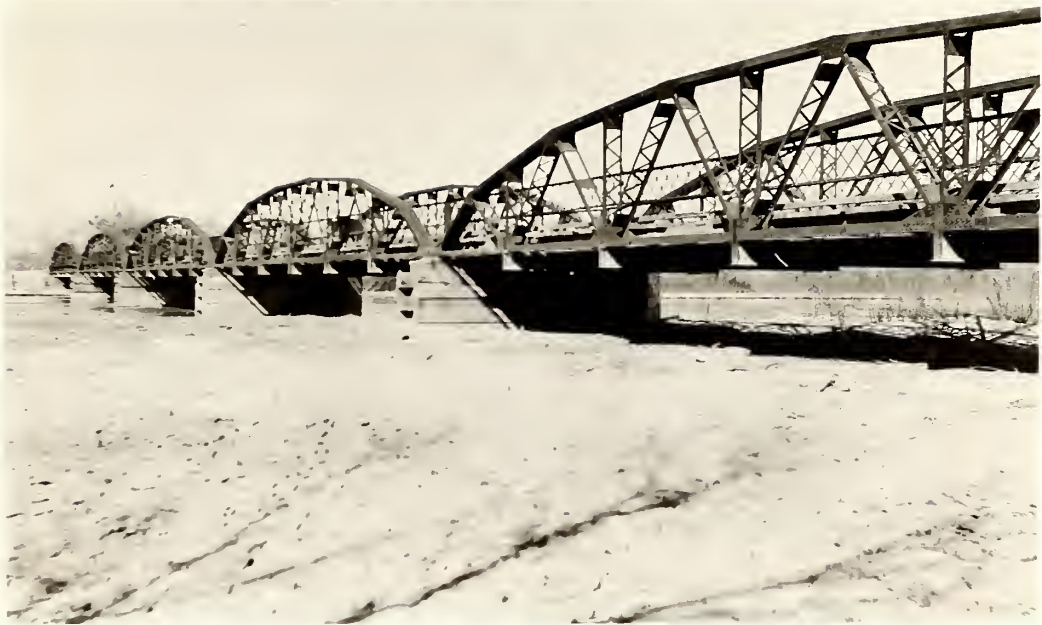
The road bridge northeasterly from San Marcial over the Rio Grande was raised about 6 feet during the summer or autumn of 1936, so when the floods of 1937 occurred the bridge was above high water and was not injured by the floods.

Rio Grande Valley. Bridge on road to Val Verde. Looking westerly
on down stream side. December 12, 1936.

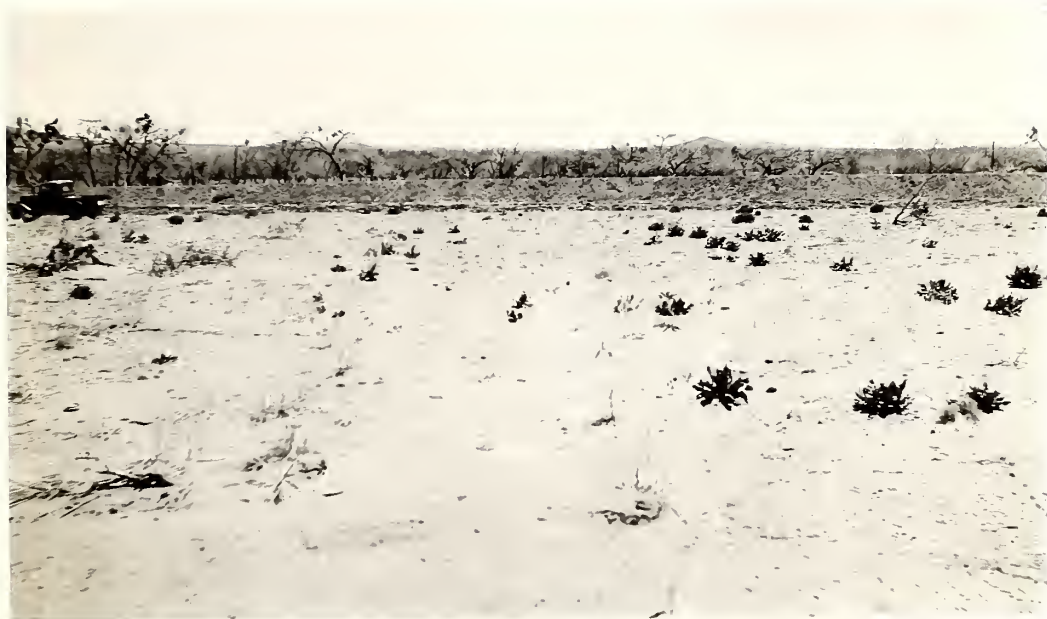
Rio Grande Valley. Cross section Line 1. Looking easterly from the edge of valley and showing deposit from Trenaquel Arroyo to the south and also the recently constructed dike of the A. T. & S. F. Railway. April 11, 1937

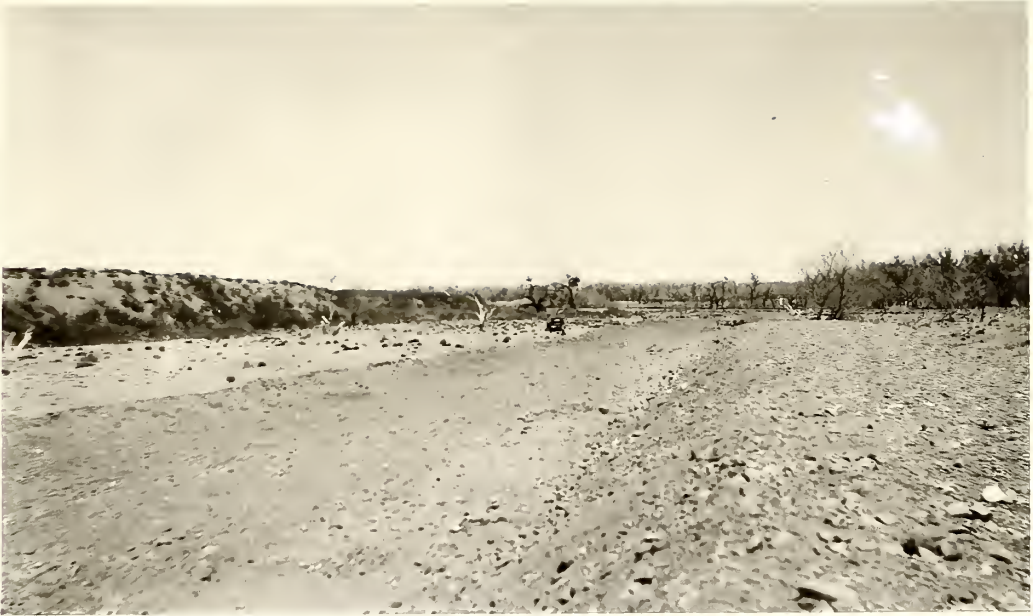
Rio Grande Valley. Cross section Line 1. Looking northerly along newly constructed dike shown in the preceding photo. Trees to left of truck are shown in following photo.

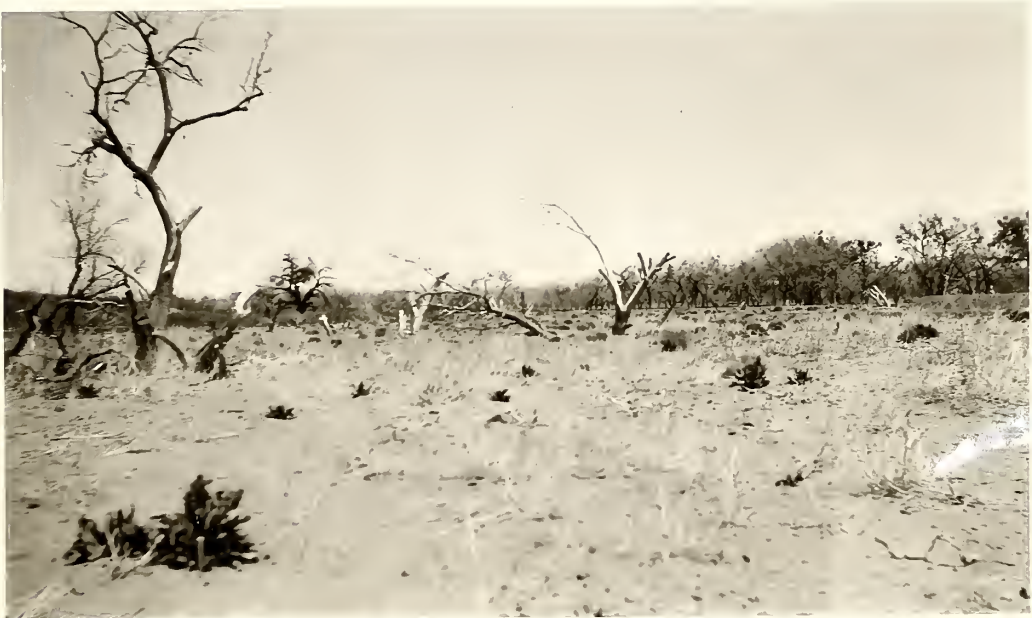
Rio Grande Valley. Looking northerly and showing deposit of silt, sand, and gravel from Trenaquel Arroyo. A detail of a part of previous photo. Deposits are from 10 to 15 feet deep.

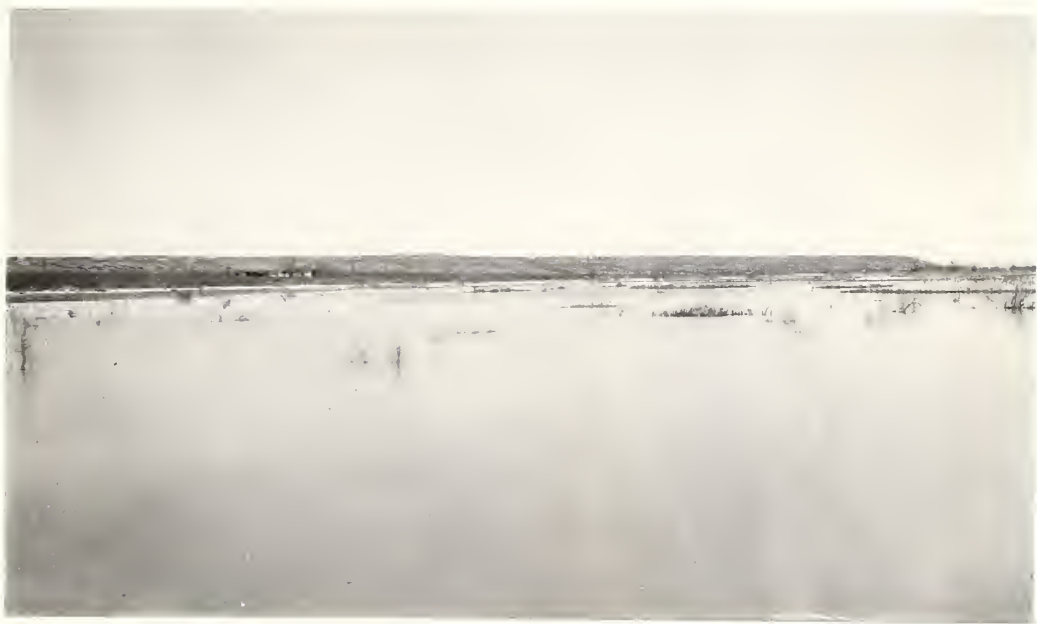
San Marcial. Looking northerly from westerly culvert on road south of Line D. Elevation of water about 4461. Triangulation Station Masalto on point of land near right center. April 11, 1937.

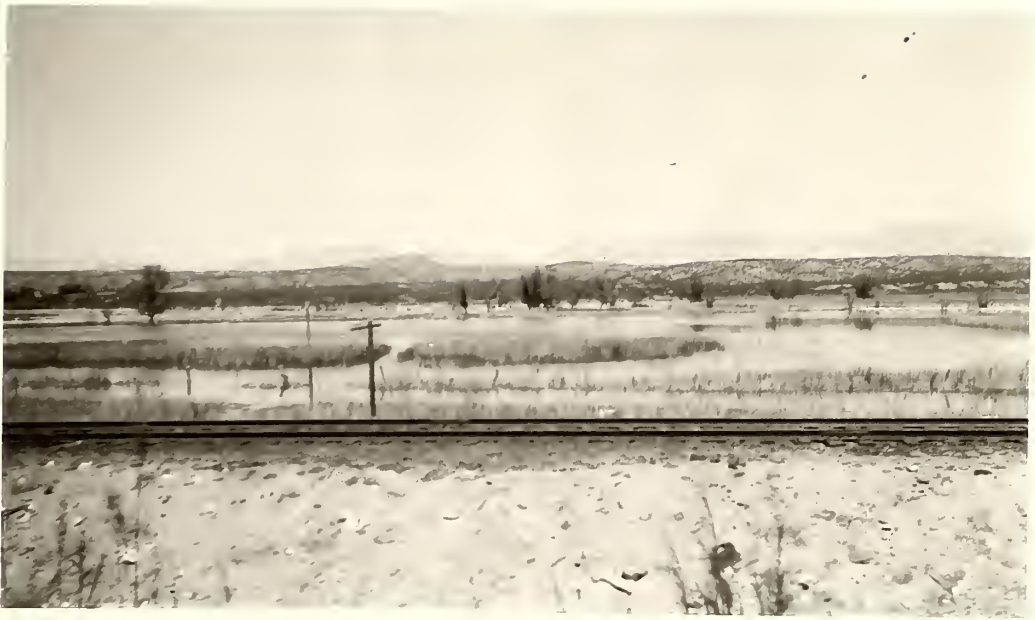
Rio Grande Valley. Cross section Line E. Looking westerly from switch track. Water about 4462.0. feet in valley.

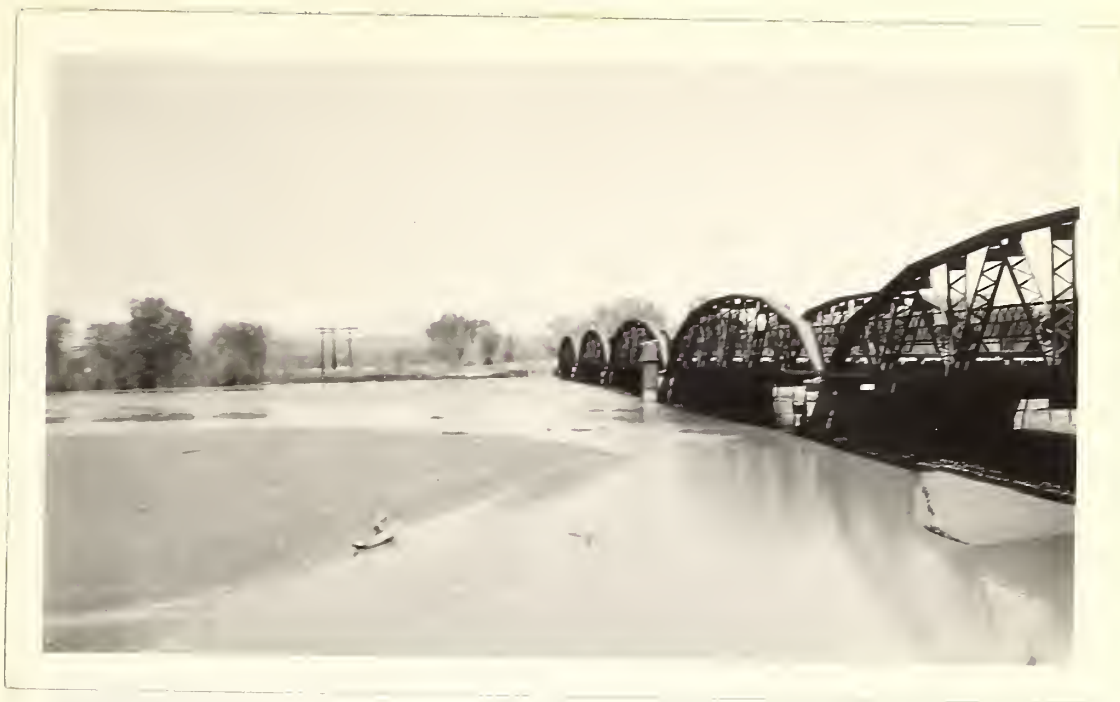
San Marcial. Looking westerly along the south side of San Marcial - Val Verde bridge. Water about one foot lower than highest during season. April 25, 1937.

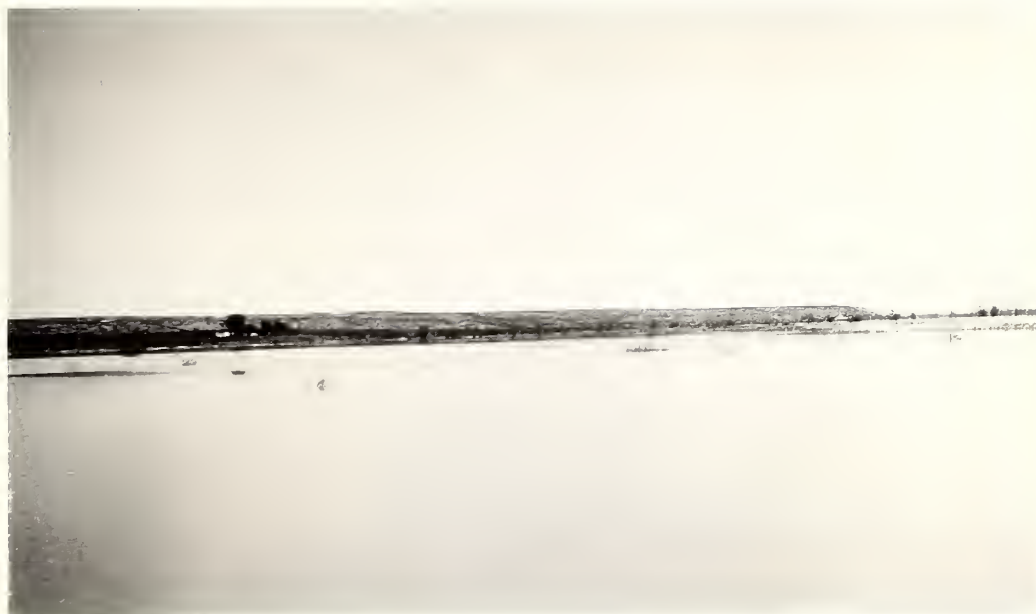
San Marcial. Looking northerly from westerly culvert on road south of Line D. Elevation of water about 4462. Triangulation Station Masalto on point of land near right center. April 25, 1937

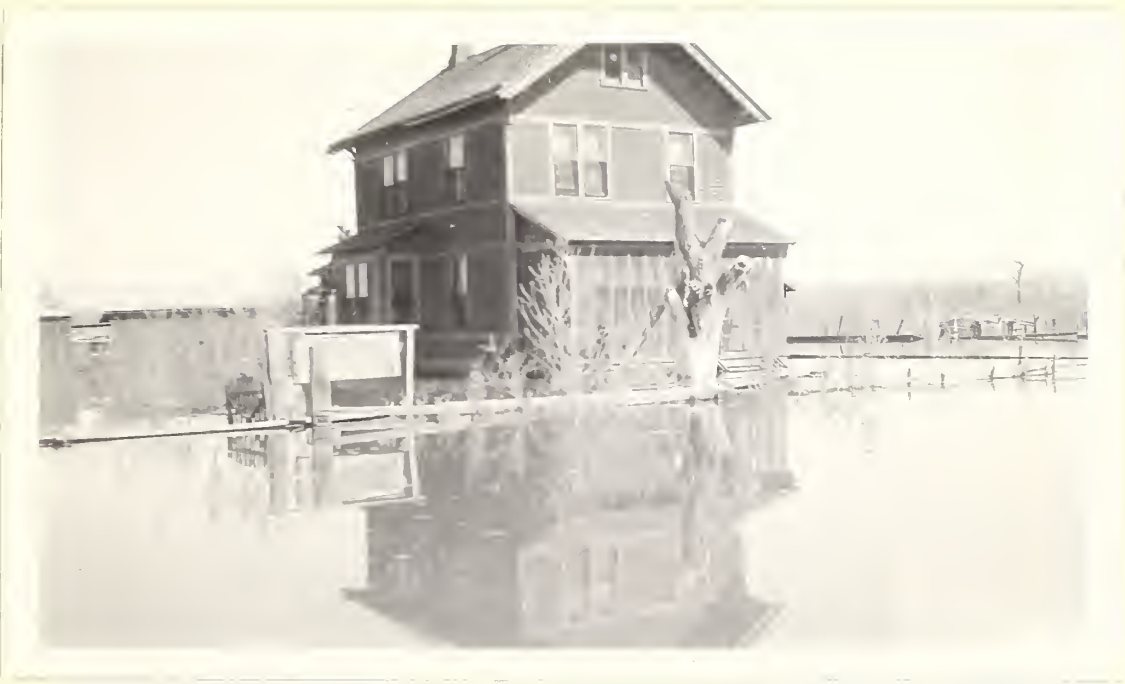
San Marcial. Former residence of division superintendent of the A. T. & S. F. Railroad. Photo April 25, 1937. Water on June 29 was 4.5 ft. higher or nearly 2.0 ft. deep above the first floor.

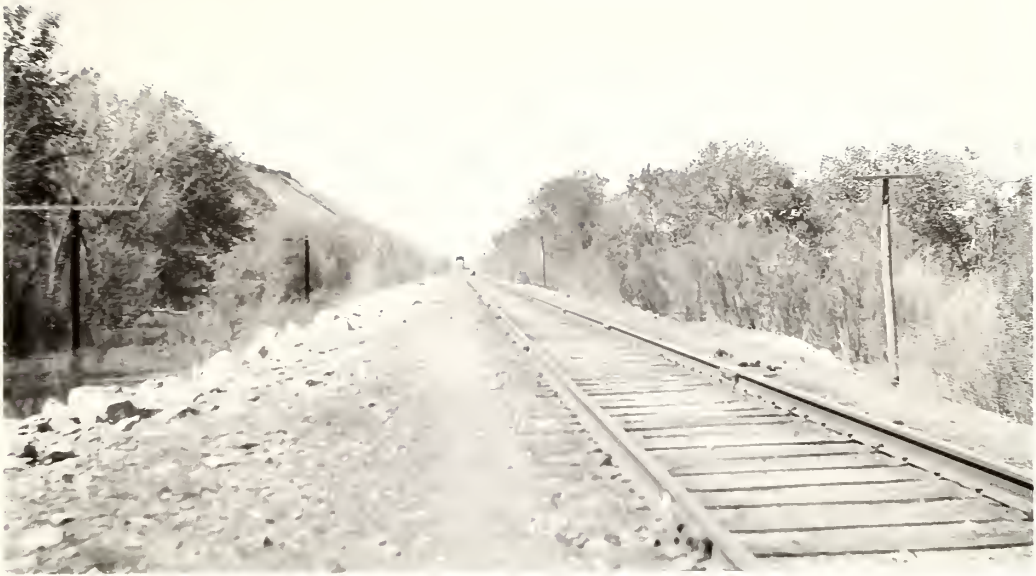
San Marcial. Looking southerly along track from near Line C.
Water on left side is 5.0 feet higher than on right side.
April 25, 1937.

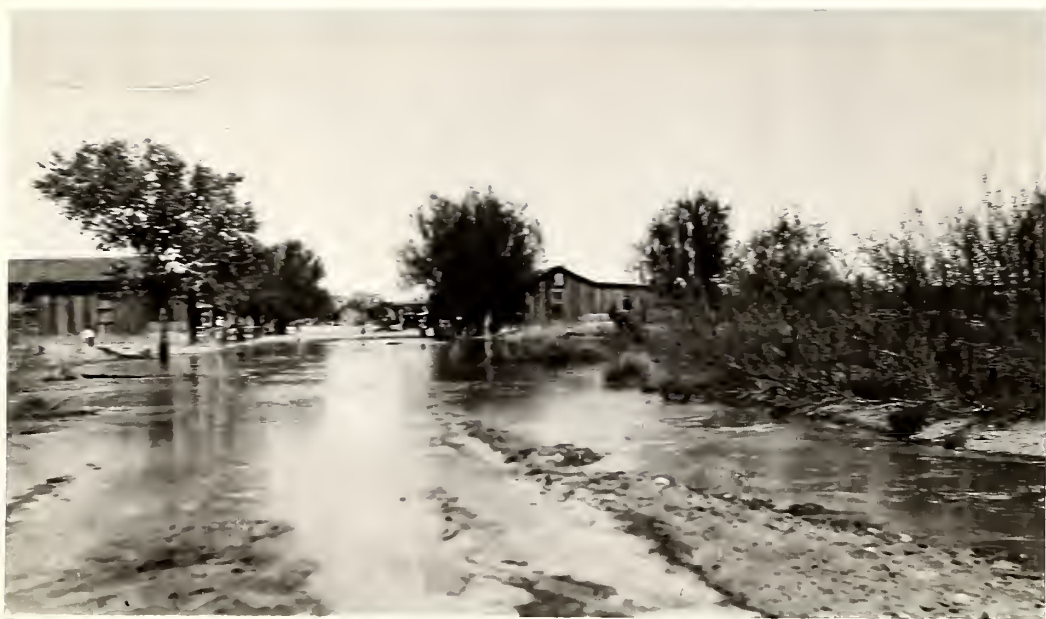
Rio Grande Valley. Old Town at San Marcial. Looking northerly and showing residence of Mr. Vivian on right. Taken April 25, 1937. Water was about half foot higher on April 29. High water approximately 4462 feet.

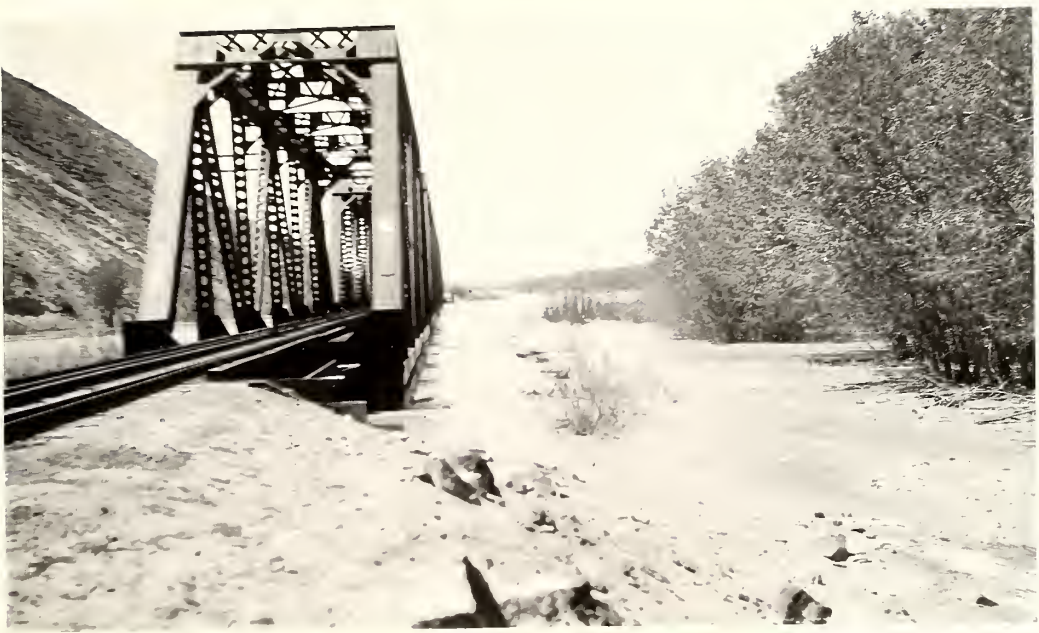
Rio Grande. Looking south along the west side of the railway bridge at San Marcial. Black Mesa is shown at extreme left. River can be seen for a mile and a half down stream. Water flowing under first span is flowing northwesterly. April 25, 1937.

I went to the railway bridge south of San Marcial and there found the water flowing against the lower part of the iron work on two spans and the clearance on the remaining spans varying from one to two-tenths foot. I estimated the discharge at 7,000 or 8,000 second feet and 1,000 second feet of this discharge was flowing up the valley instead of down the valley. Conditions are such that an alluvial cone is being built below the railway bridge on the lands containing brush and trees, and this cone evidently is building very rapidly as the quantity of water flowing northwesterly was very great. I estimated that 150 second feet were flowing along the north abutment of the railway bridge and flowing nearly parallel to the railway grade. This water which flows northwesterly from the railway bridge is what is causing the back water near the town of San Marcial more than a mile away.

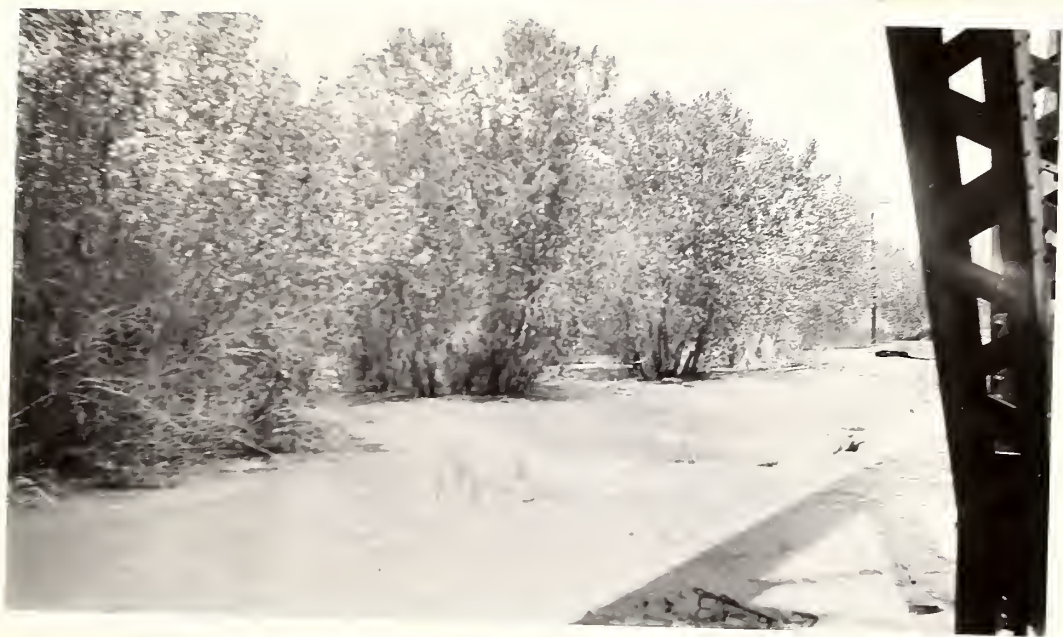
Rio Grande. Looking northwesterly from the west side of railway bridge at San Marcial. Water shown in photo is flowing northwesterly. April 25, 1937

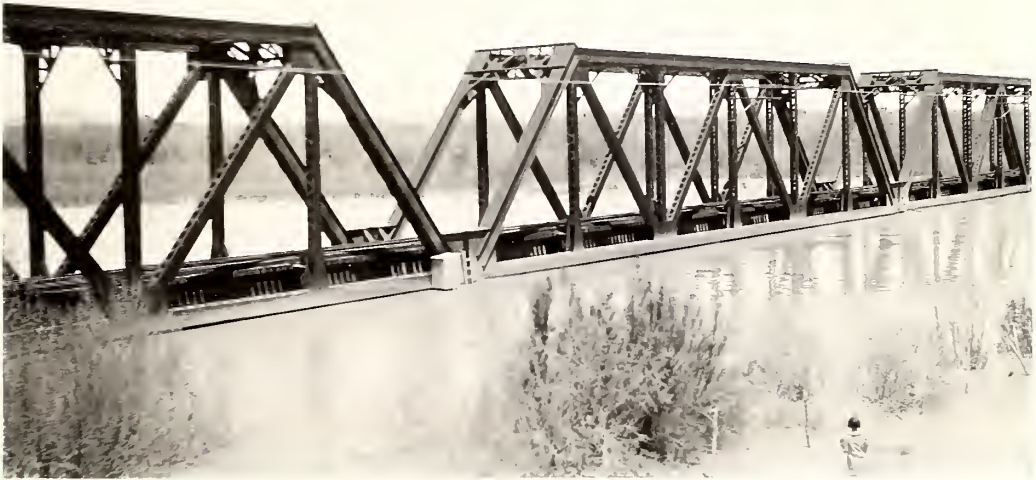
Rio Grande. Looking northwesterly and showing a part of the south half of the bridge of the A. T. and S. F. Railway. Recorder shelter of International Boundary Commission's gage installed in February, 1932. Water about one tenth below bridge. April 25, 1937

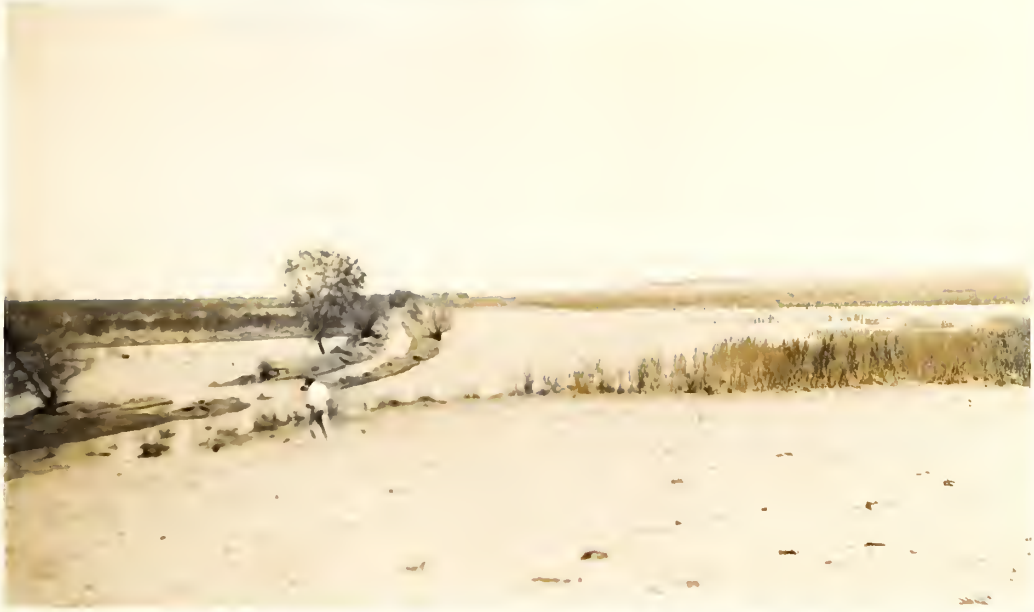
Rio Grande Valley. Looking northerly and showing break in Val Verde ditch due to pocketing of water which flowed from above Olguin Ranch. Line H crosses near tree on left side of ditch. About 200 second feet flowing through breaks. April 28, 1937.

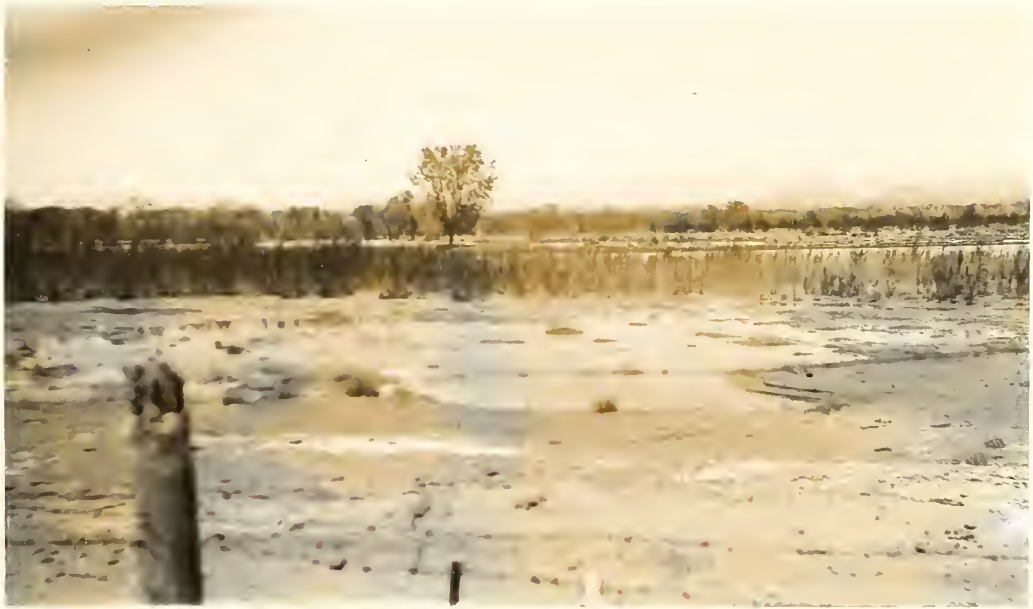
Rio Grande Valley. Cross section Line H. Looking westerly from near elevation of 4480 feet. Tree near center is on west side of Val Verde ditch. Water had been 2.5 feet higher than shown due to pocketing.

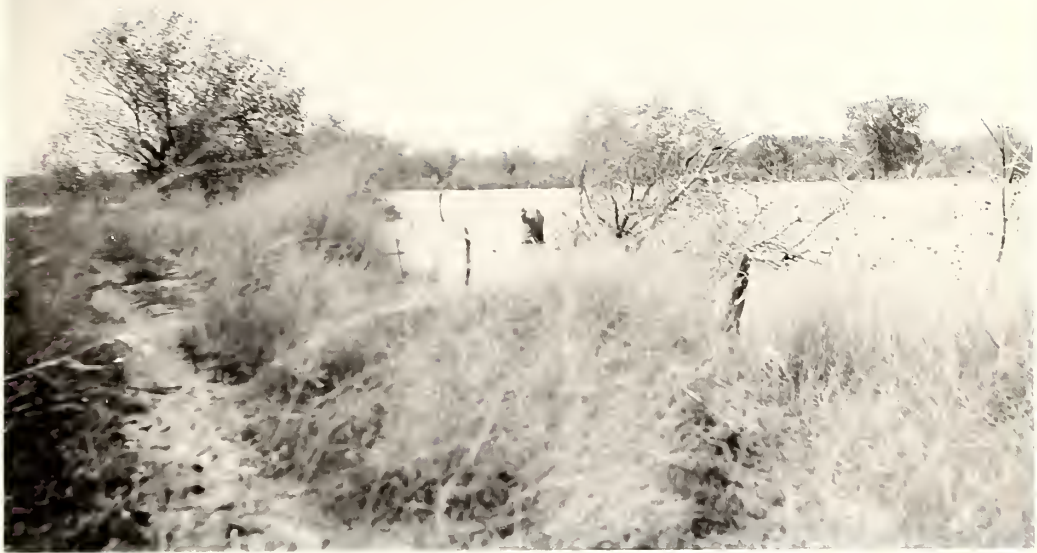
Rio Grande Valley. Cross section Line G. Looking westerly from stake marked 55+00. Water surface 4471.5 feet in elevation. April 28, 1937

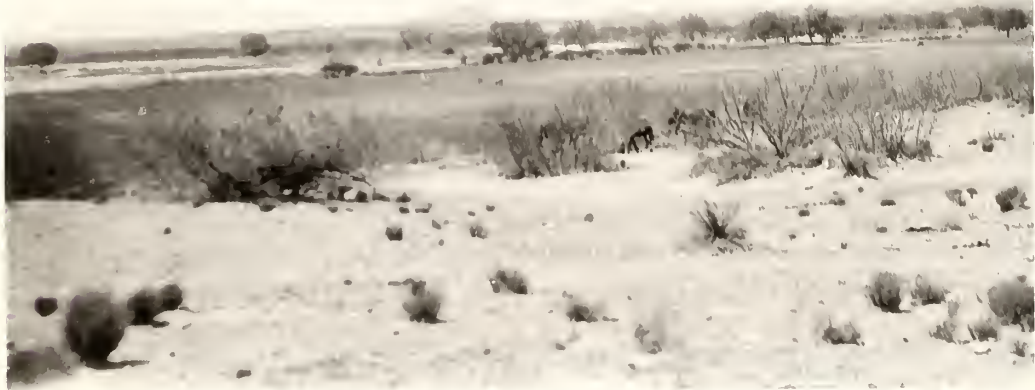
Rio Grande Valley. Cross Section Line G. Looking westerly from a point 75 feet westerly from triangulation station Apodaca. Valley area not flooded near center, flooded area beyond. April 28, 1937

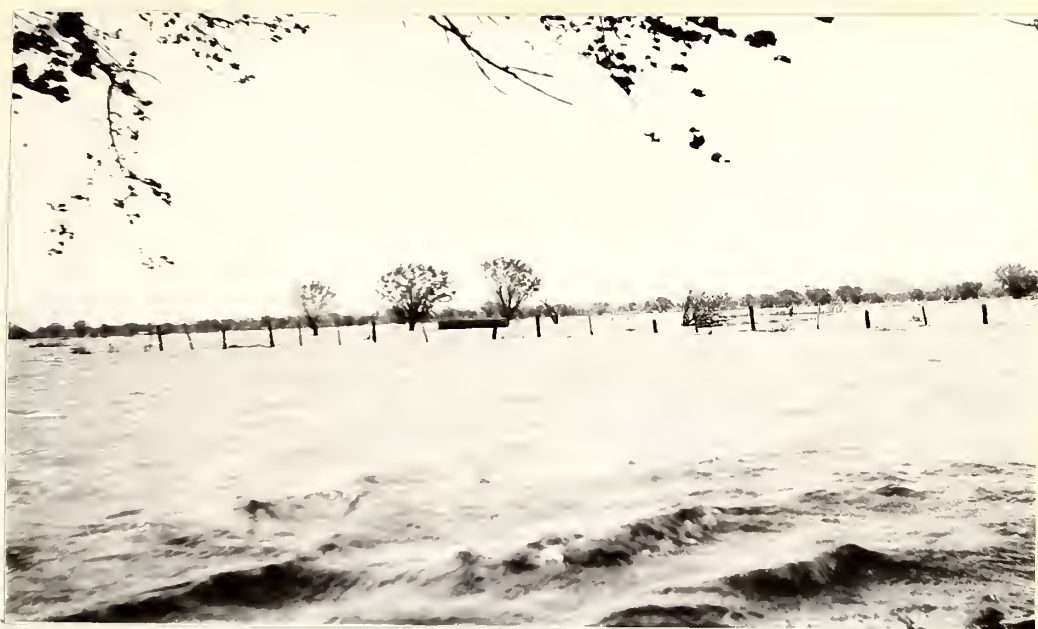
Rio Grande Valley. Looking westerly from a point of land about 1000 feet northwesterly from Triangulation Station Flor Amarilla. Jacal shows near center. Water surface about 4468 feet.

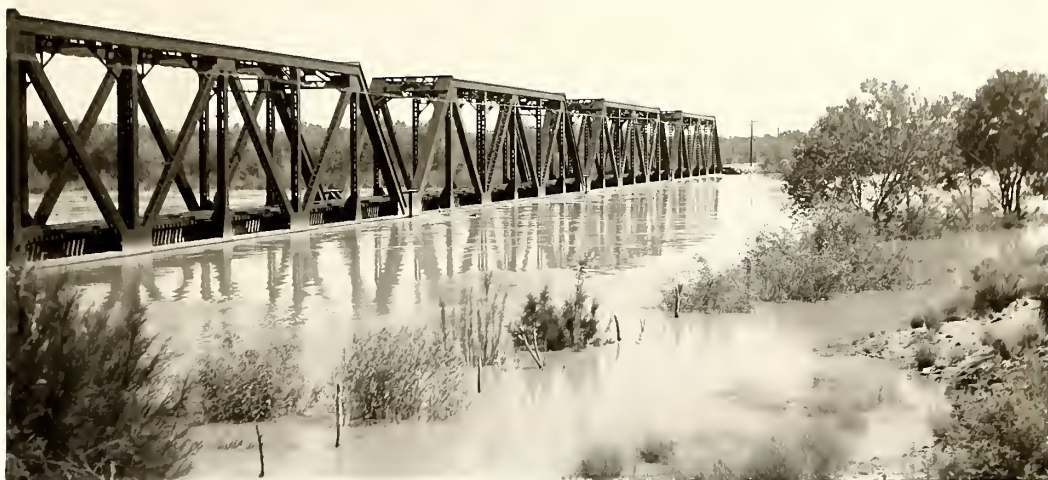
Rio Grande. San Marcial. North half of Railway brodge. Water about half foot deep on lowest girder.

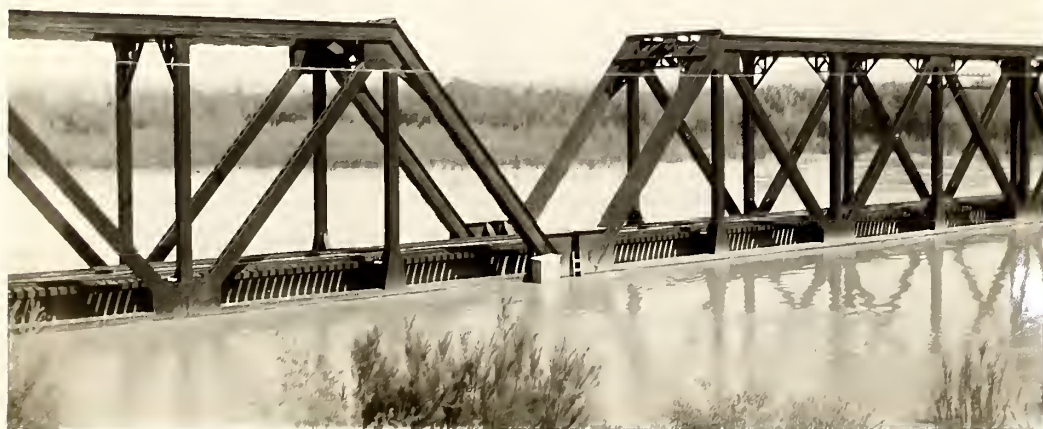
Rio Grande. San Marcial. Looking northwesterly and showing a part of the south half of the bridge of the A. T. & S. F. Railway. Water about half foot higher than April 25, 1937.

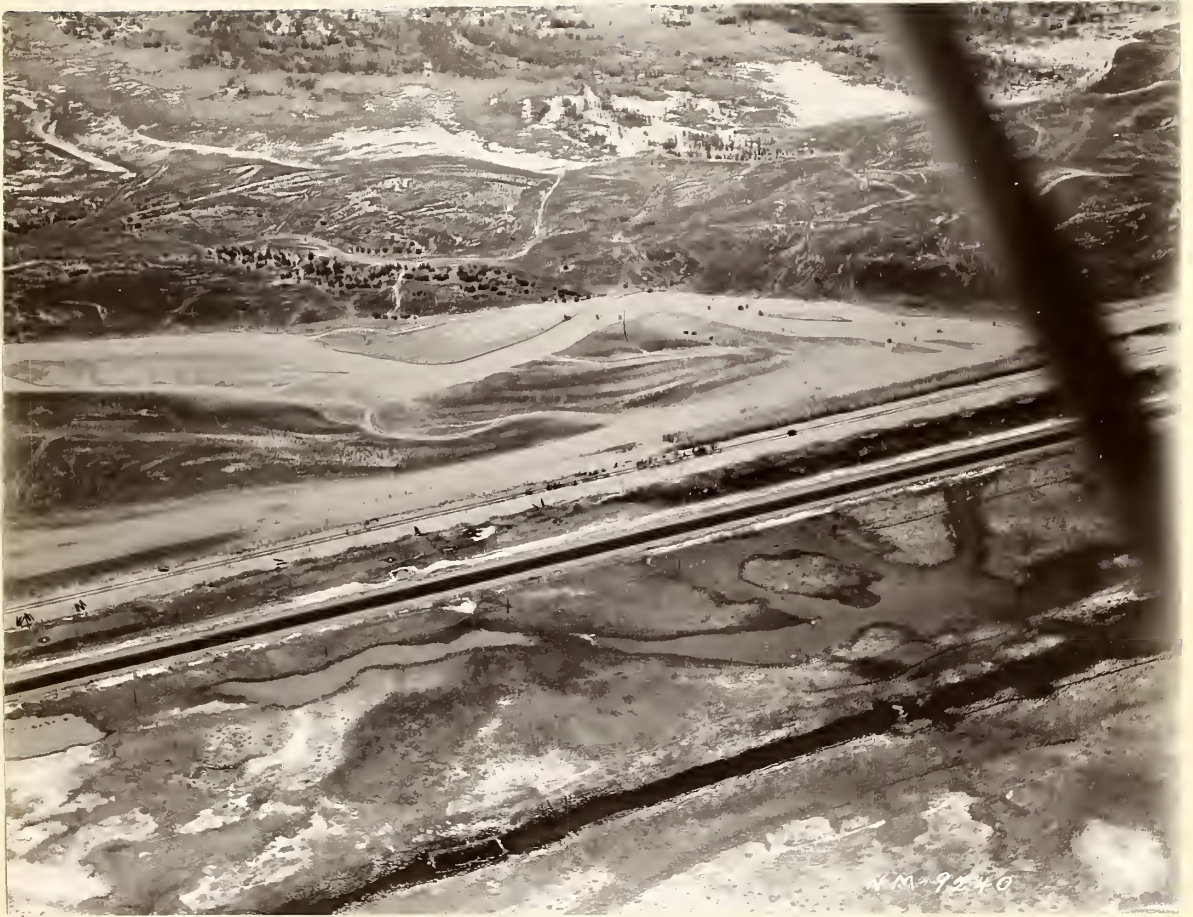
Work crews engaged in raising the railroad track to counteract the effects of lateral overflow. Near mile 997. Looking southeast.

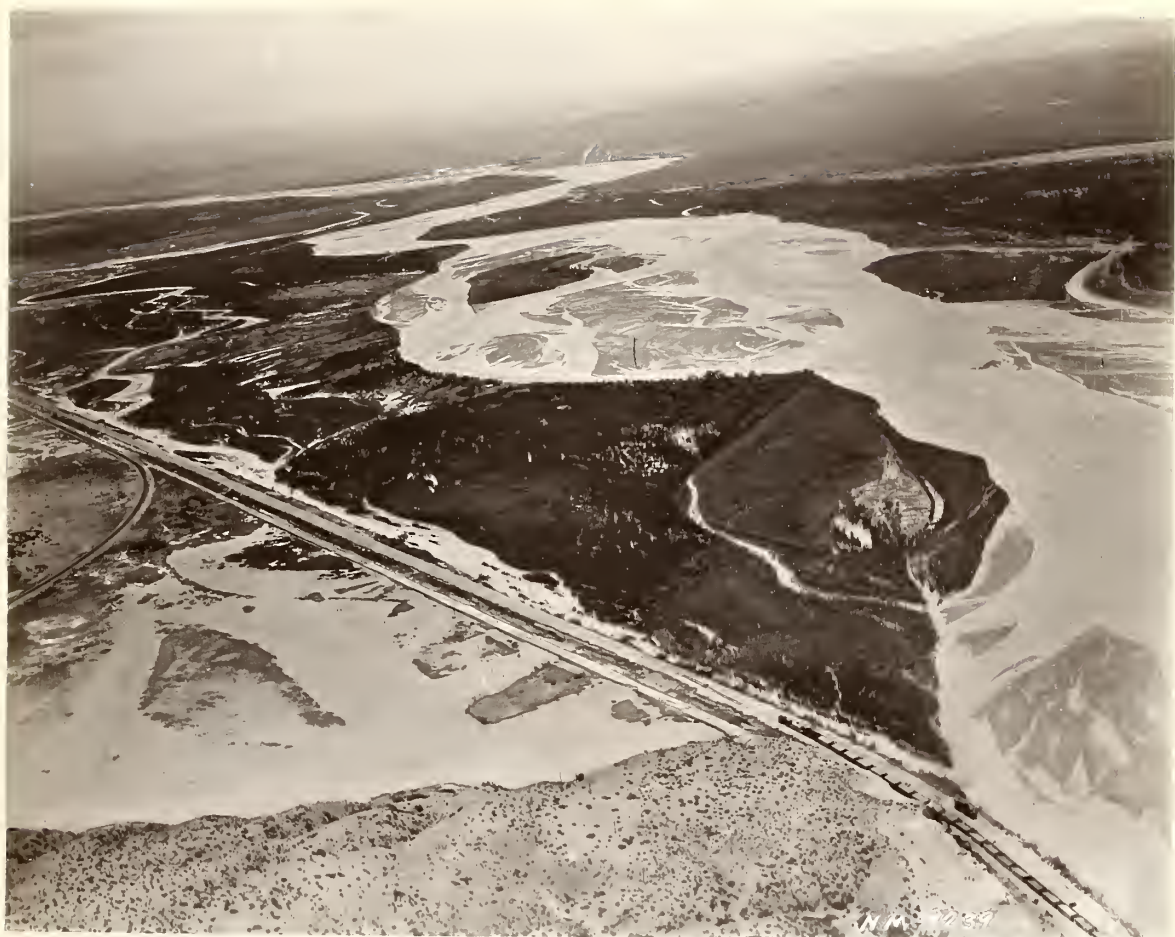
High water below Elmendorf. Between Point of Land and mile 997 on railway. Shows a work train engaged in raising the fill and track. Silt bars exposed by receding water are visible in the upper center. Looking upstream from Point of Land.

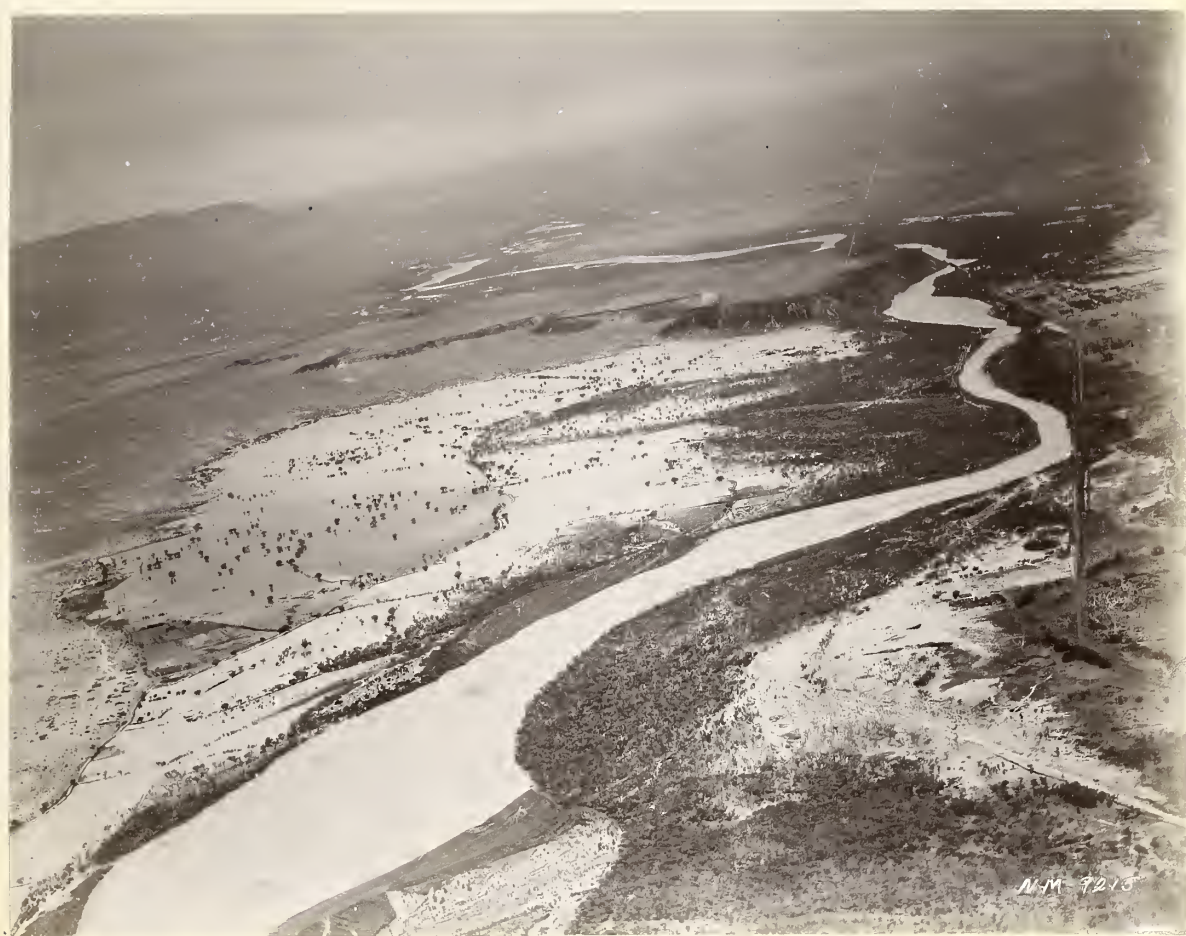
Looking down the Rio Grande. Water flowing through Tiffany Ranch in right foreground. Val Verde extreme left foreground. Still and partly clear water near Val Verde. Fra Cristobal Mountains left background. A. T. & S. F. Ry. at right.

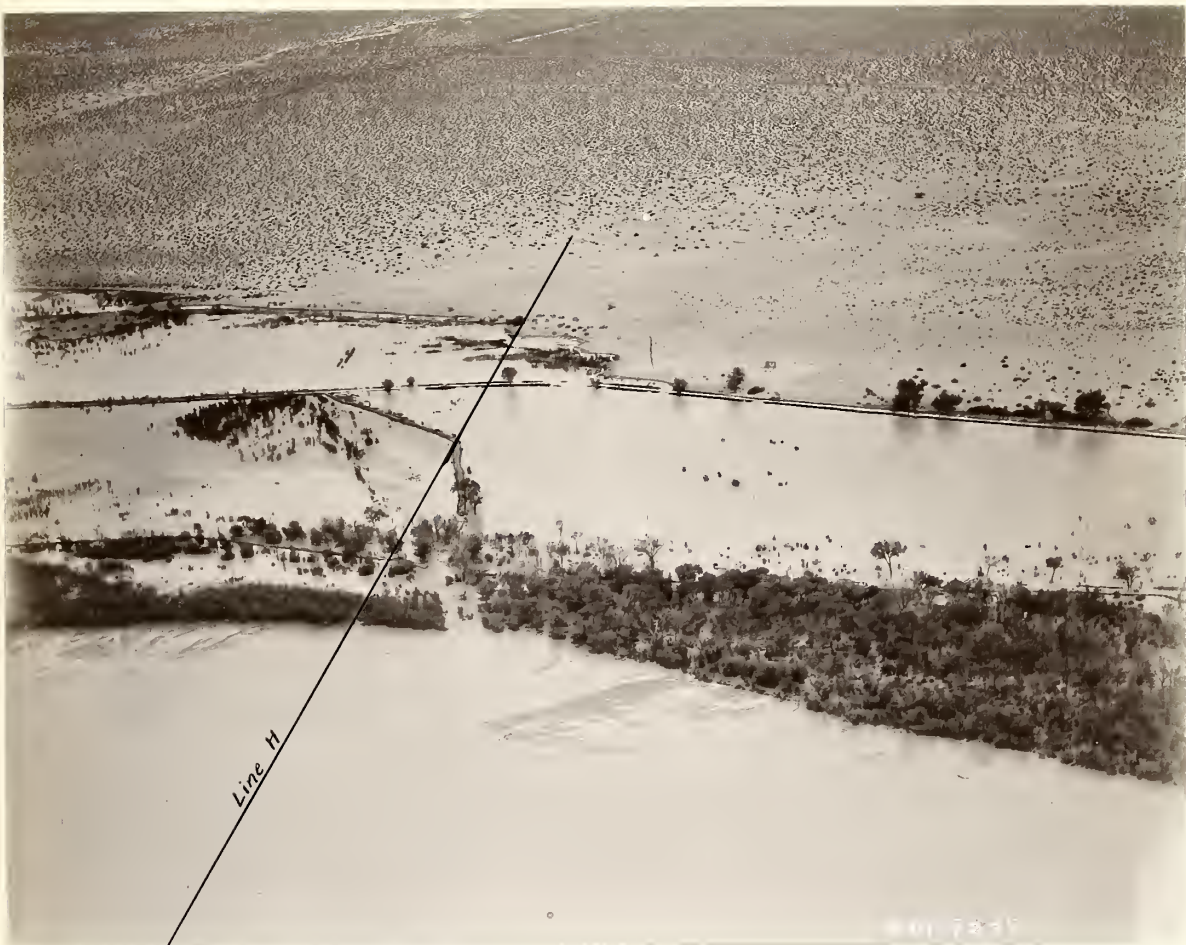
Flooded area north of Val Verde showing large breaks in the dike. The water area in the foreground is the river itself. Looking northeast.

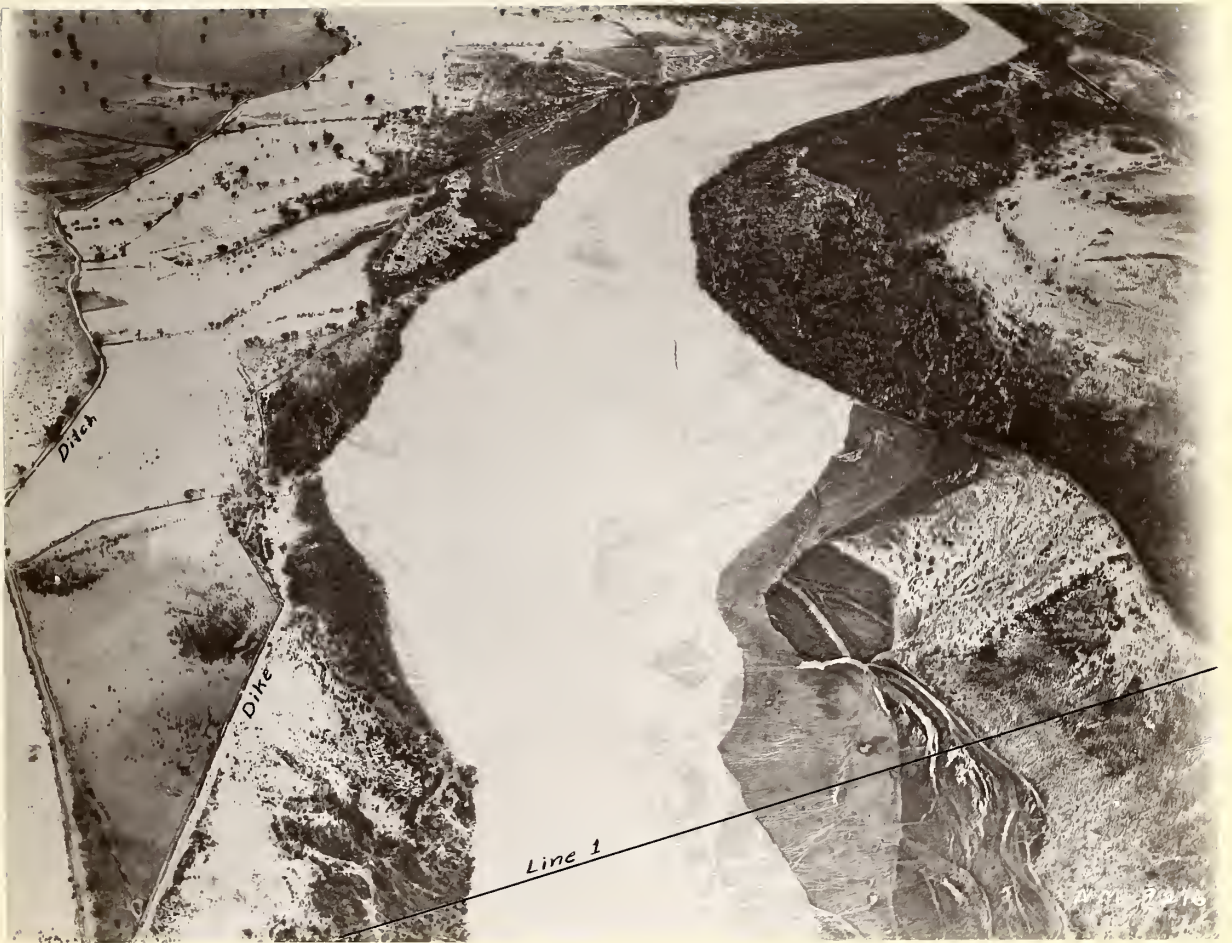
North end of flooded area near Val Verde, looking downstream. Showing the agricultural land under water and the silt bars in the river being exposed by receding waters.

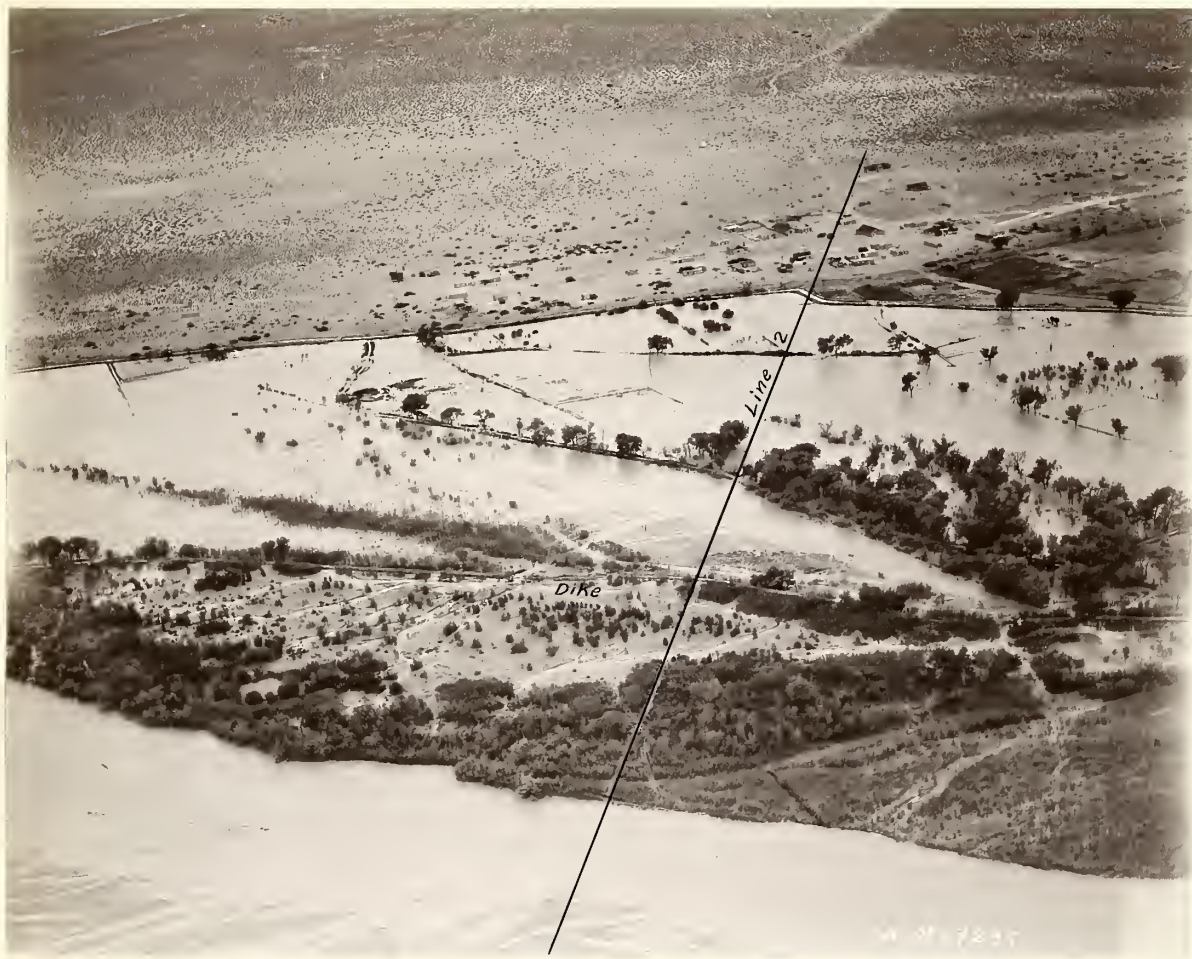
Flooded area near Val Verde. Showing flood water entering through breaks in the dike. Looking east.
